# New Europe College Regional Program Yearbook 2005-2006

# THE PROBLEM OF PRESERVING EXTERIOR WALL PAINTINGS ON MONUMENTS: A COMPARATIVE STUDY OF LATE MEDIEVAL PAINTED CHURCHES IN BUCOVINA (ROMANIA) AND SLOVENIA\*

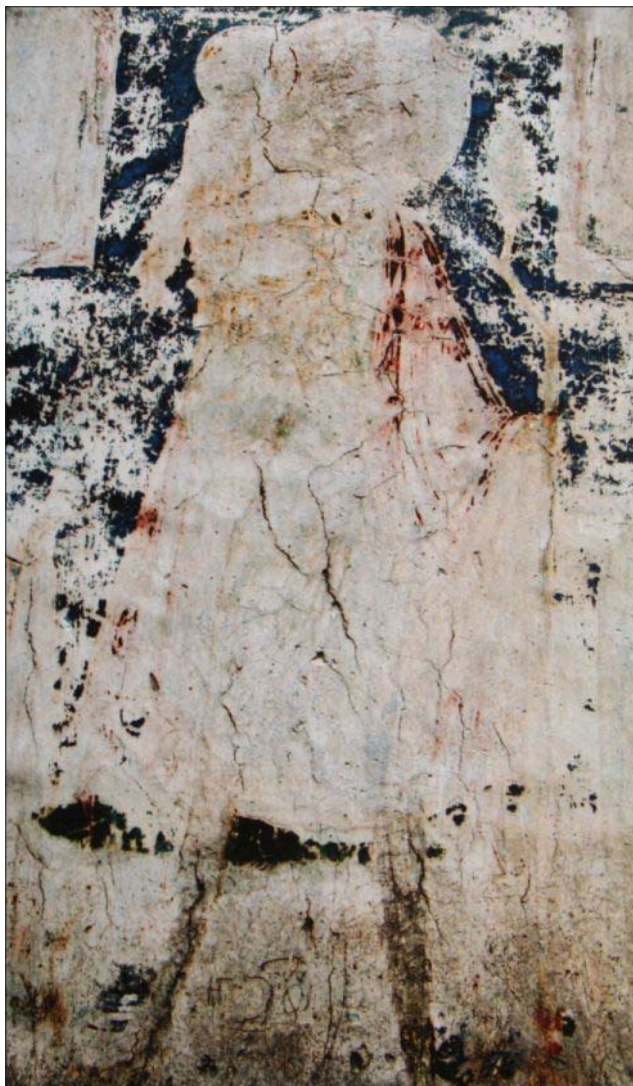
Figure 2: Arbore, church of Decollation of St. John the Baptist, Bucovina; wall painting of St. Christopher on the east façade of the wall of the altar apse. This is the only preserved exterior depiction of St. Christopher in Bucovina from the late Middle Ages (painted by Dragoş Coman of Iasi, 1541).

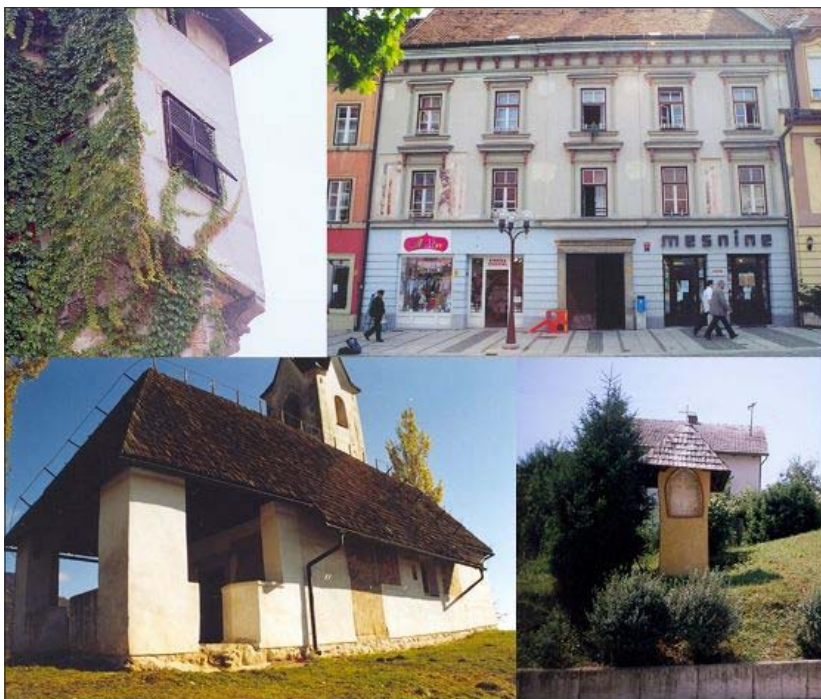
Figure 3: The remaining medieval wall paintings in Slovenia are in most cases on the exteriors of sacred monuments (churches, chapels and shrines). To the side can be seen a wall painting from the façade of the castle, the civic house and the rural house. The state of preservation of these paintings differs considerably: from small fragments of only a few cm<sup>2</sup> to large areas covering the entire wall.

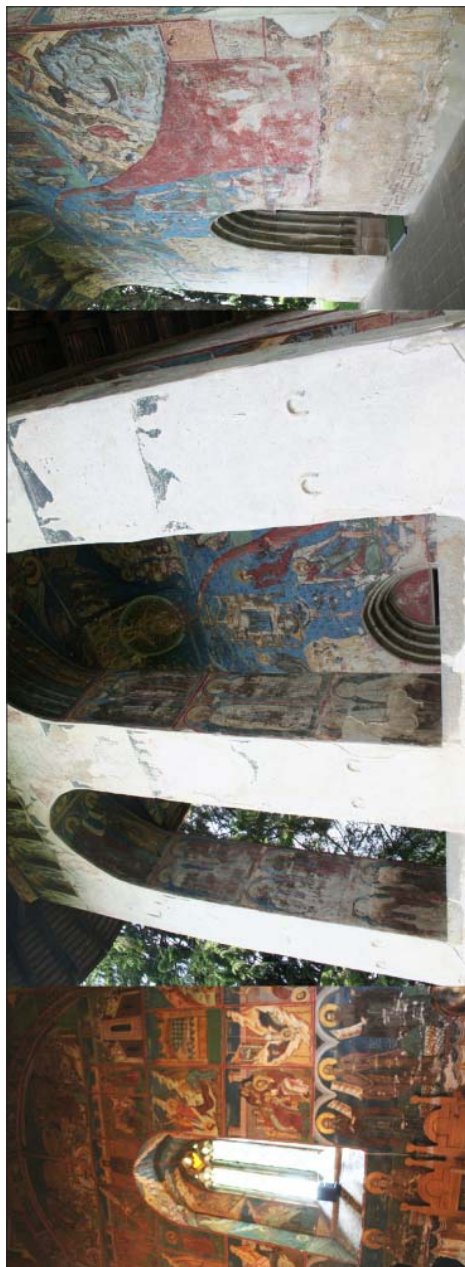
Figure 6: Church of the Dormition of the Virgin at Humor; collage of three photographs – (left) segment of interior wall painting, (center) faint fragments of paintings on western facade, and (right) exterior paintings protected by the vault of the porch (all painted by Thomas of Suceava or his workshop between 1530 and 1535).

To show that wall exterior wall painting is far more at risk than interior painting it suffices to select just one monument with both interior and exterior wall paintings painted in the same period and by the same artists or workshop. Some examples of comparisons at the churches of Humor in Bucovina and of Zanimgrad in Slovenia are shown in Figure 6 and Figure 7, respectively.

As already mentioned in the example of the church at Humor (Figure 6), the state of preservation of exterior wall painting can depend considerably on the level of protection from precipitation. Clearly, exterior wall paintings entirely under the roof or with an additional overhang are more protected than those under a short cornice or with no overhang.

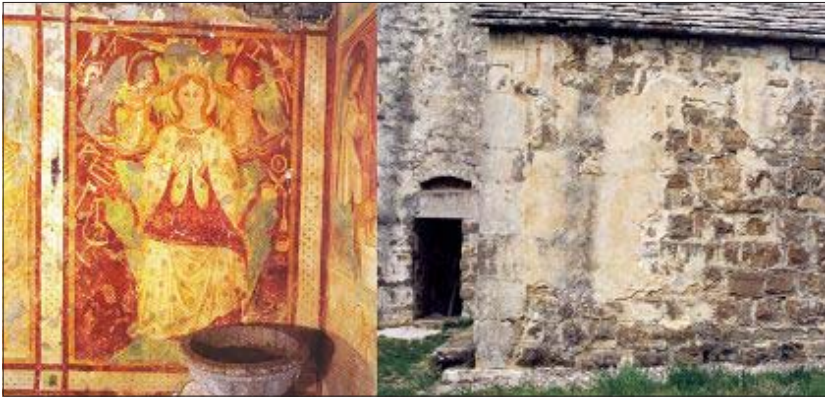
Figure 7: Church of St. Stephen at Zanigrad: this shows an extreme example of difference in preservation for wall paintings painted by the same author and on the same wall, inside (left) and outside (right).

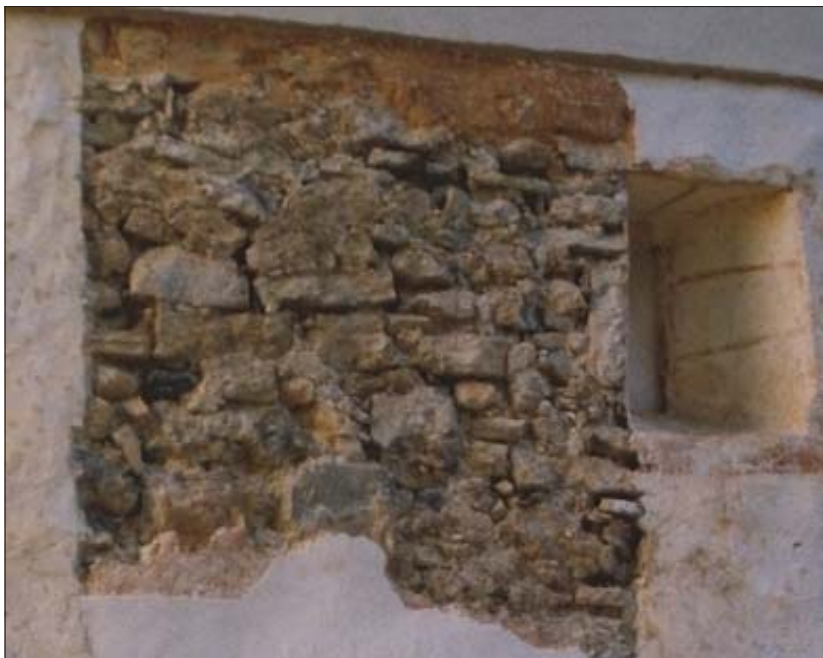
Figure 9: Church of St. Urh at Vihre. South wall of the nave;  
example of irregular composing of stones.

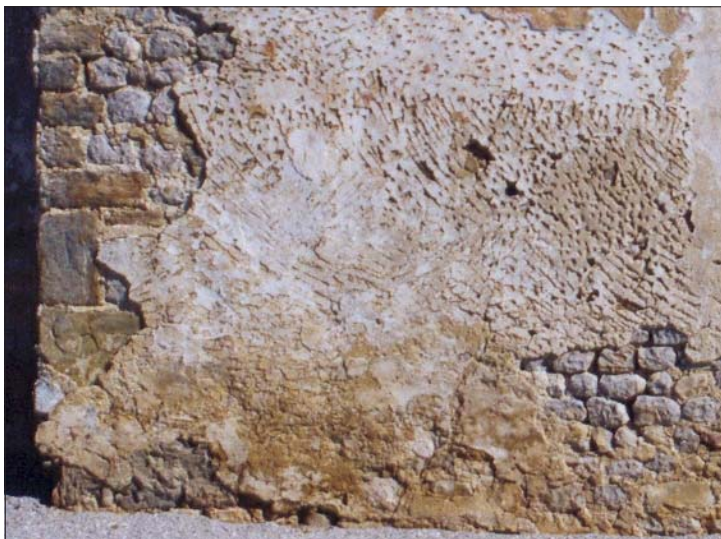
Figure 10: Church of Sts Primus and Felicianus at Gorenje Karteljevo. South wall of the nave; example of stratified composing of stones.

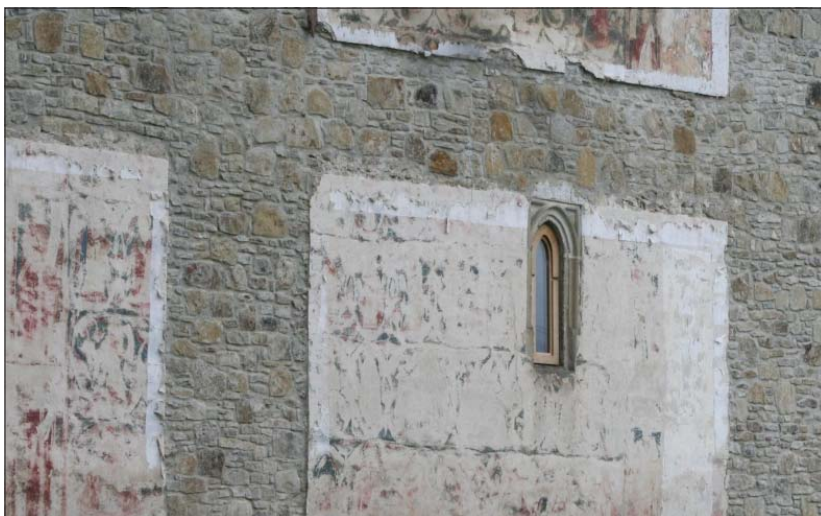
Figure 11: Church of the Dormition of the Virgin at Baia, southern wall; clearly visible masonry where wall paintings were detached.

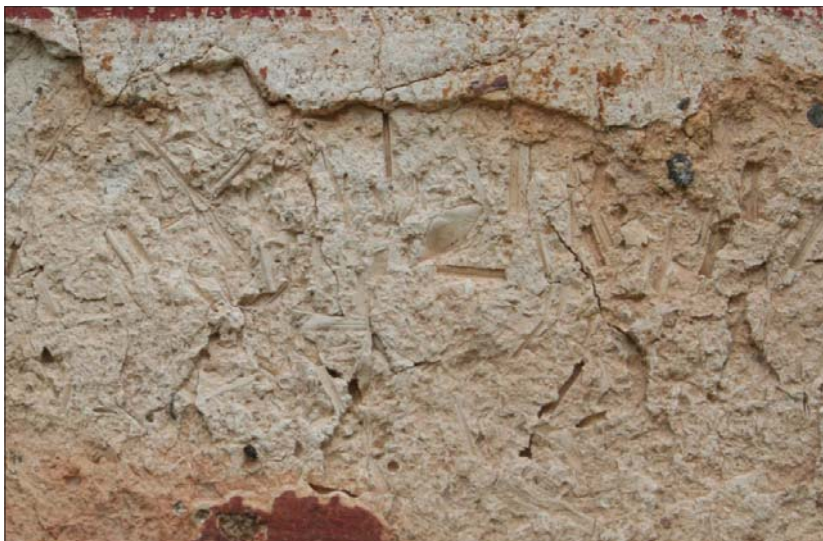
Figure 12: Church of St. Nicholas at Rasca, southern wall;  
cut straw in the plaster.

The particular difference between plasters of the monuments in Bucovina and Slovenia is seen in their composition. In Bucovina, the cut straw typical of Byzantine plasters can be found. This was used to make the plaster stronger and retain the moisture for longer. For similar reasons crushed brick (or other organic or inorganic supplements) was added but its use is seen less frequently and sparser in Bucovina. By contrast, the medieval plasters in Slovenia very often contain greater amounts of crushed brick and the usage of organic compounds like cut straw is very rare. This type of plaster in Slovenia is more typical of ancient Roman plaster and later periods. Another special type of plaster also found in

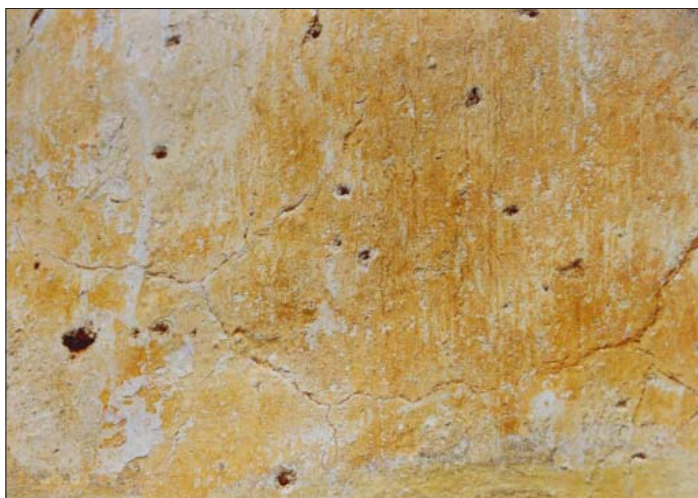
Figure 13: Church of St. Martin at Zalog, southern wall;  
particles of crushed brick in the plaster that caused damage  
in the form of eruptions.

Slovenia is characterized by its content of particles of unslaked lime. According to one theory (Fister, 156) this may be due to the application of the type of plaster named *quicklime plaster*. In both kinds of plaster (in Romania and Slovenia) particles of charcoal can be seen sporadically. In moisture-laden walls, the existence of these various hygroscopic particles can be dangerous in the long-term because it can contribute to different forms of damage (e.g. eruptive phenomena).

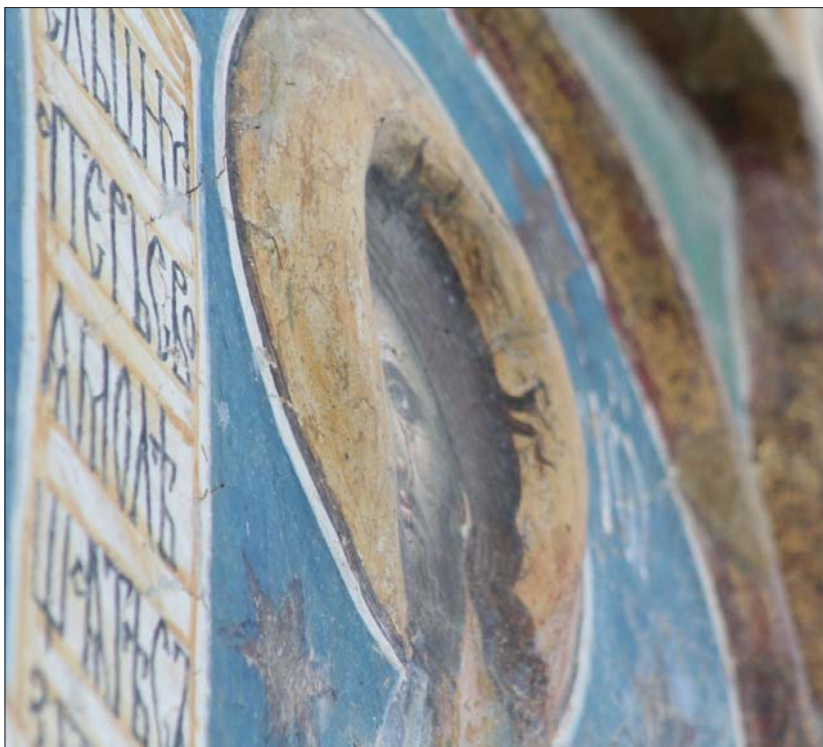
Figure 14: Church of St. George at Voroneț, south façade;  
application of nimbus with some traces of surrounding gilding.

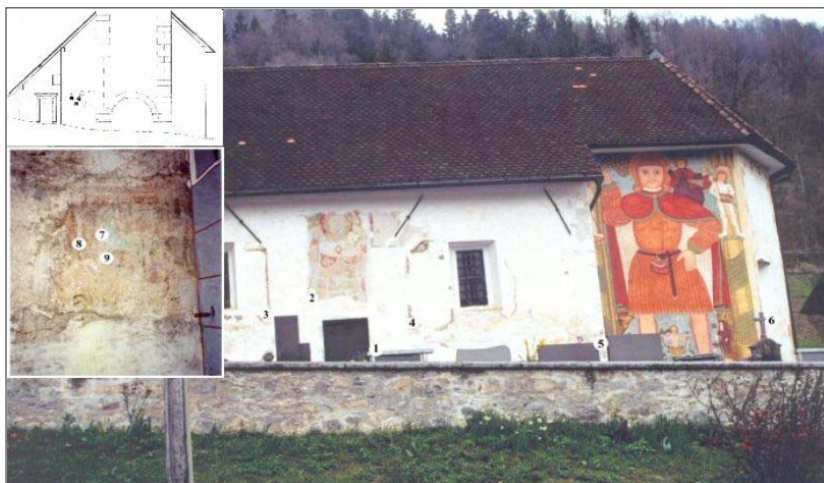
Figure 16: Church of St. Kancian at Vrzdeneč; samples taken from the  
south façade and from other sides for instrumental analysis in the  
laboratory.

Due to various restrictions, additional instrumental analysis was made only for the painted exteriors of the Church at Vrzdenc in Slovenia in 2004 and 2005. At this time, sampling and analyses of painting material, moisture, salts and microorganisms on the painted surfaces were carried out in cooperation with Slovenian experts from the Slovenian Restoration Centre and many other institutions. The purpose of the Vrzdenc pilot project was primarily to make a study of the applicability of different methods of investigation and to link together experts from various fields for possible future interdisciplinary cooperation.

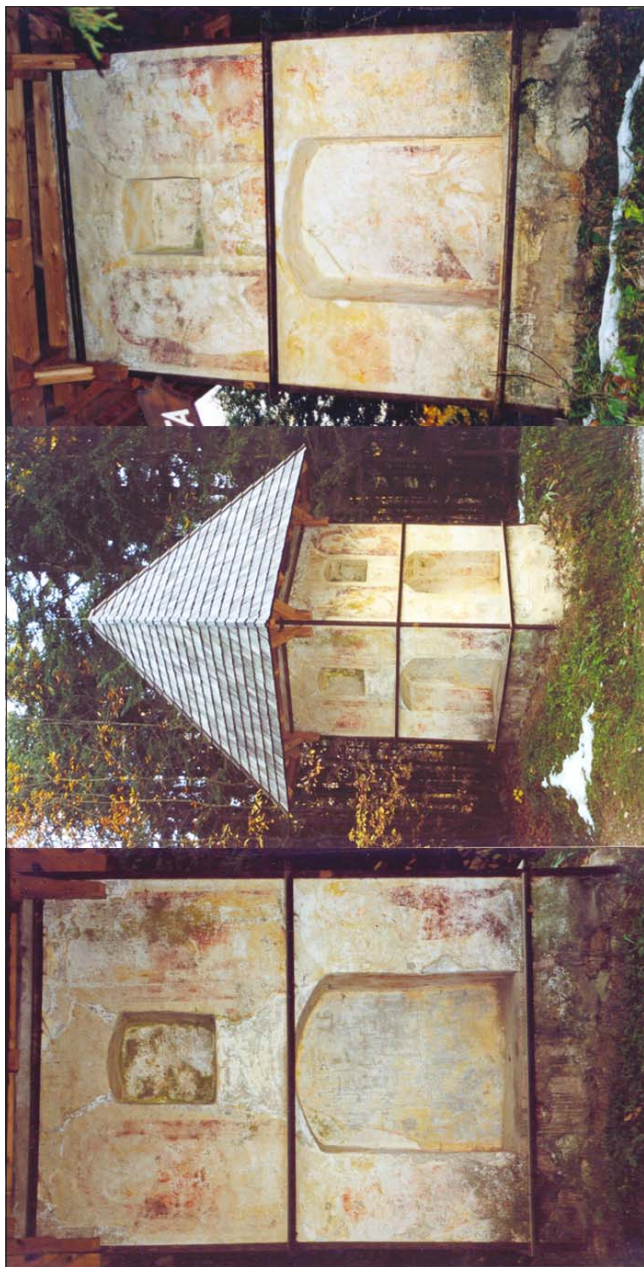
Figure 20: Crngrob, "Red shrine"; the shrine together with the northern (left) and southern sides (right).

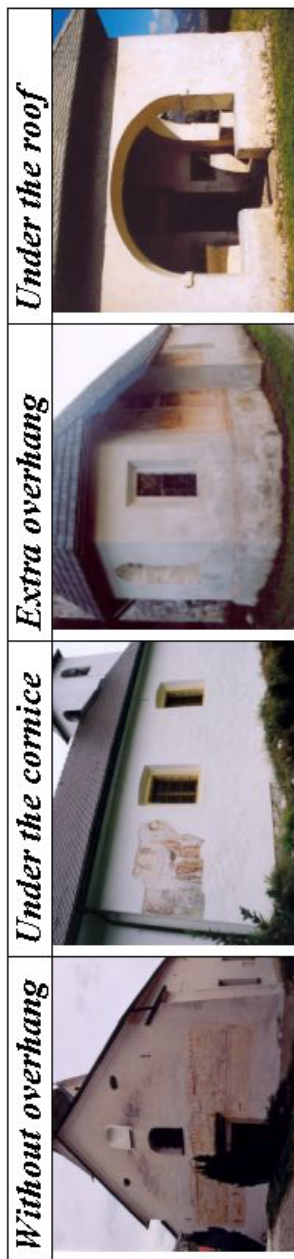
Figure 22: Different degree of protection of exterior wall paintings from precipitation for medieval monuments in Slovenia.

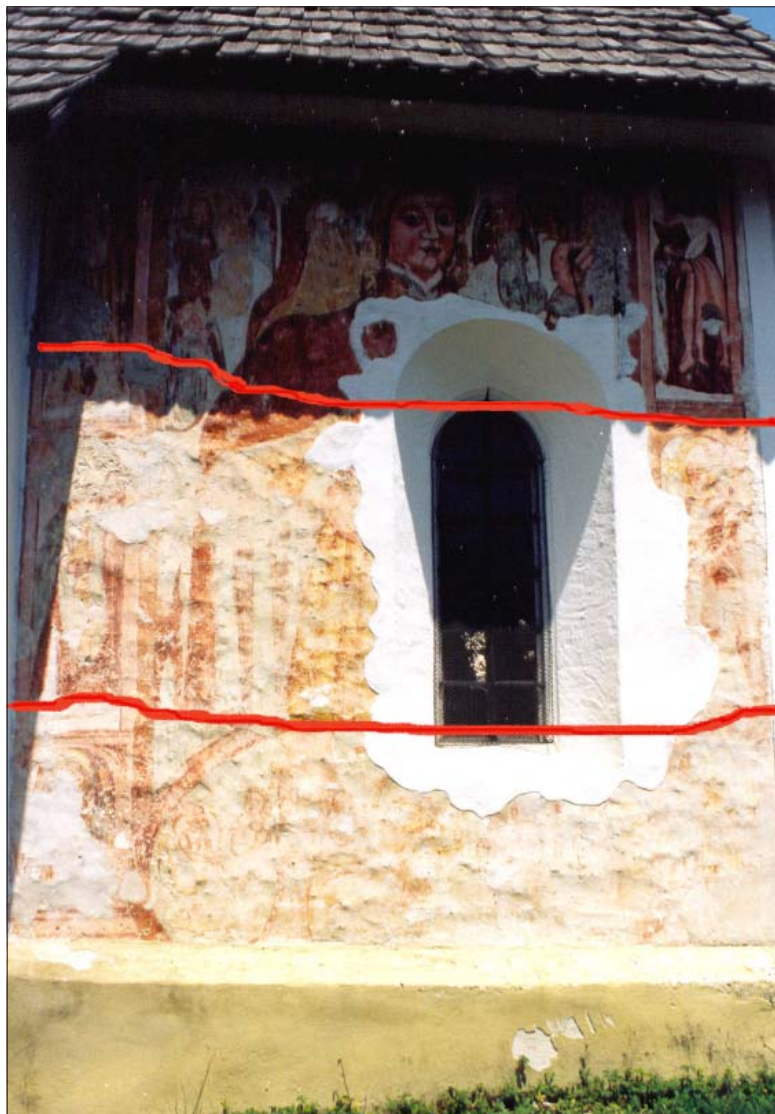
Figure 24: Church of Mary Magdalene at Brod in Bohinj, southern side of the presbytery; the lowest section of the painting is marked by combined influence of capillary action of ground moisture and precipitation.

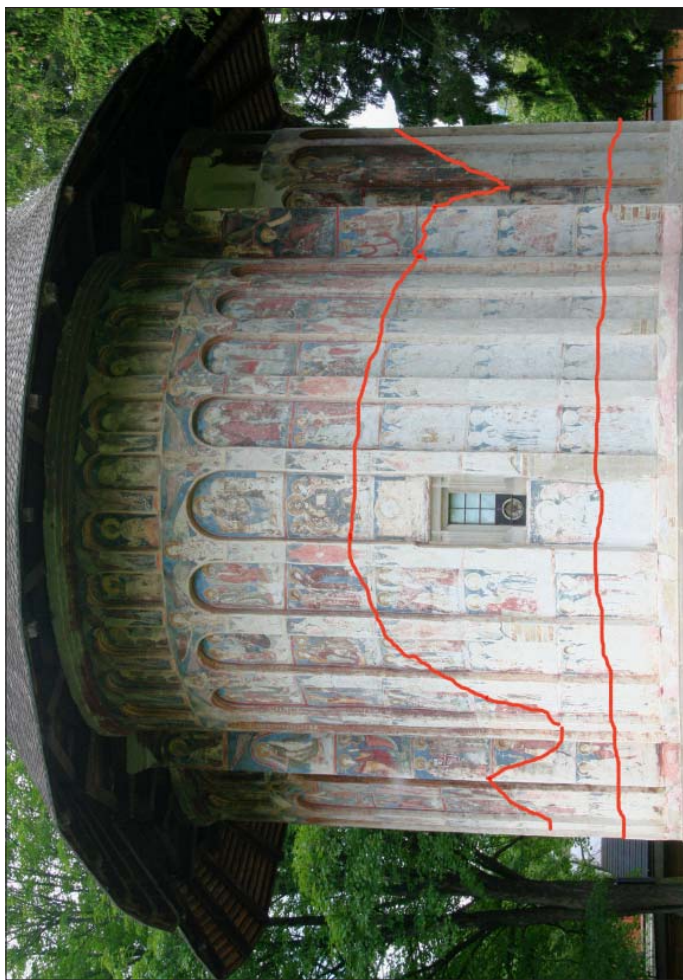
Figure 25: Church of the Assumption of the Virgin at Humor, eastern side of the apse; the size and the shape of the highest and the best preserved section of the painting is also affected by the semicircular shape of the apse and consequently the shape of the cornice that protects the paintings from precipitation, stronger winds and direct sunlight.

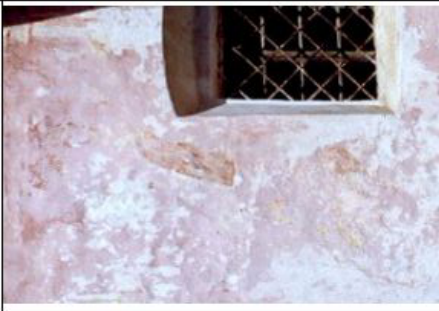
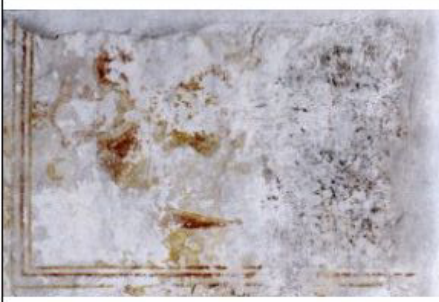
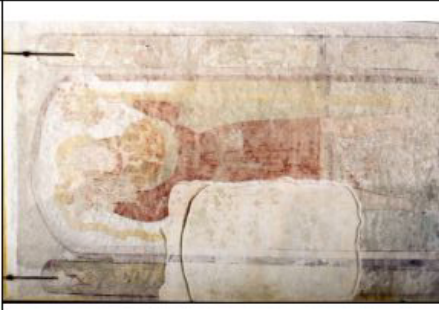
Figure 26: Different extents of uncovering from plaster, white wash, overpainting or other secondary depositions.

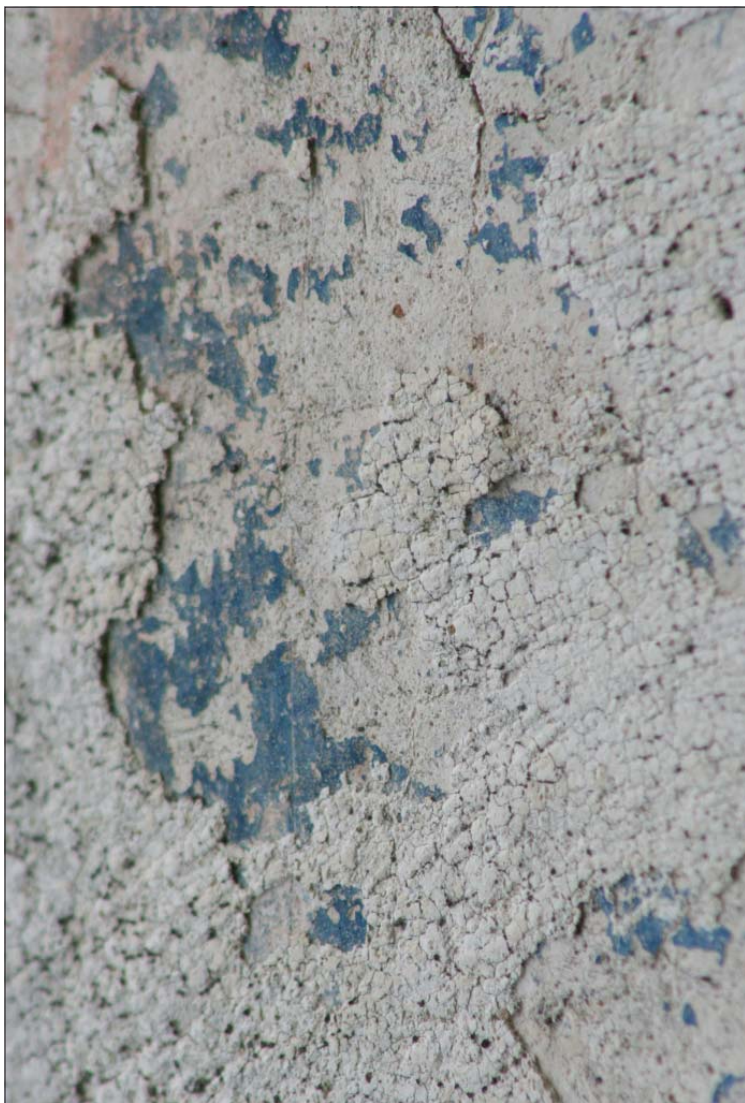
Figure 29: Church of the Feast of the Annunciation at Moldovita, northern wall; thick whitewash or very thin plaster that covered the remnants of original painting also flaking off the wall.

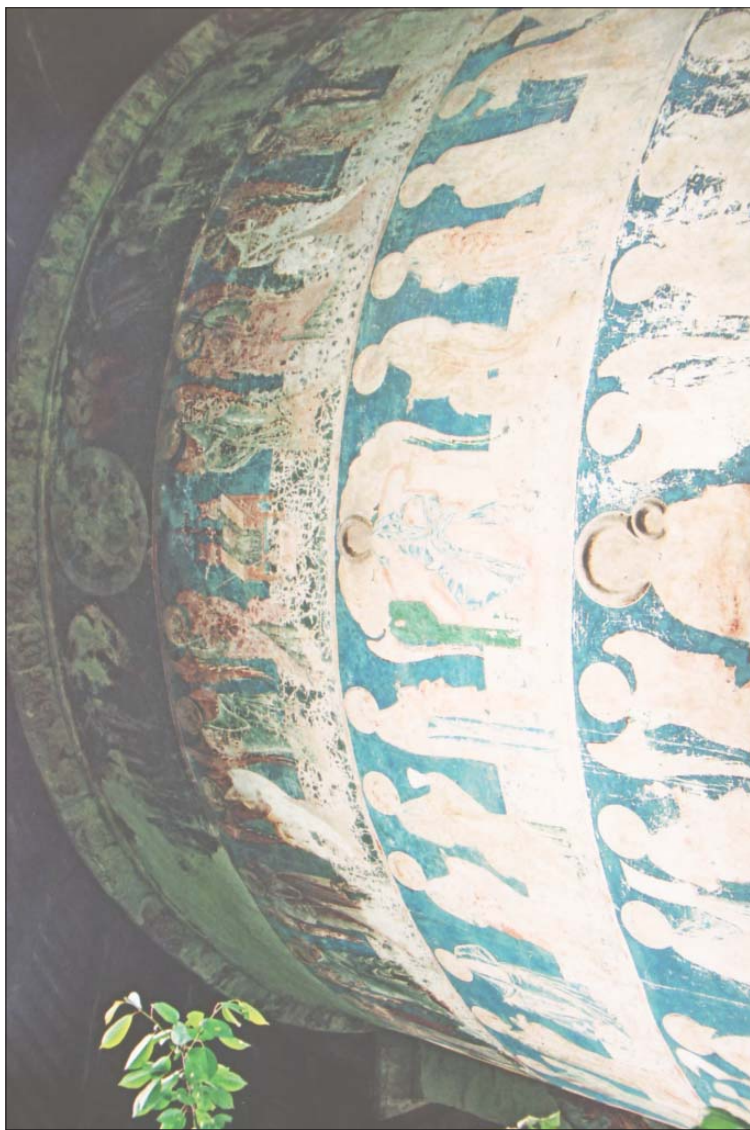
Figure 34: Church of the Beheading of Saint John the Baptist Arbore; southern apse; the surface painted with blue azurite is much better preserved than surfaces in other colors.

One somewhat contradictory phenomena observed on exterior wall paintings on the churches in Arbore, Voroneț, Moldovița, Probota and elsewhere is that some parts painted in blue azurite or green malachite are much better preserved than other parts of the same painting painted with earth pigments (Figure 34).

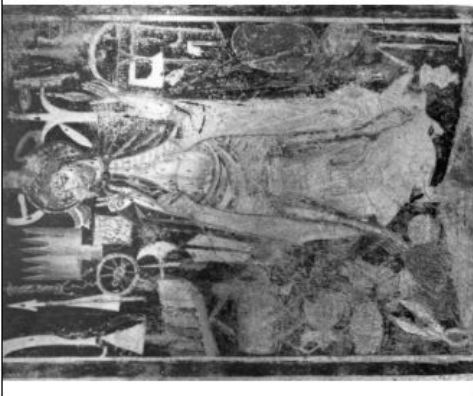
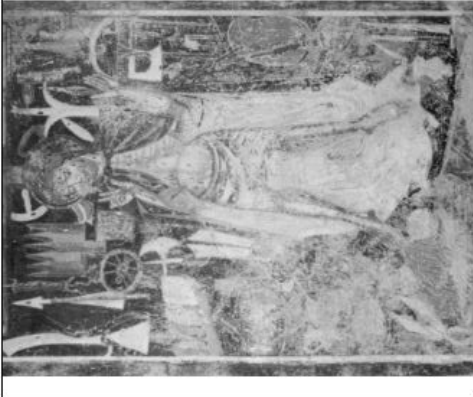
Figure 38: Church of St. Leonard at Bodešče; the rate of change in surface appearance over a timescale of about eight decades.

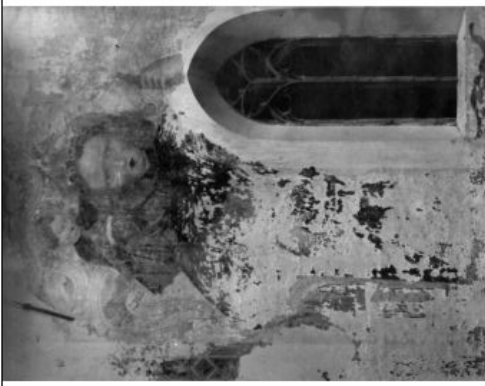
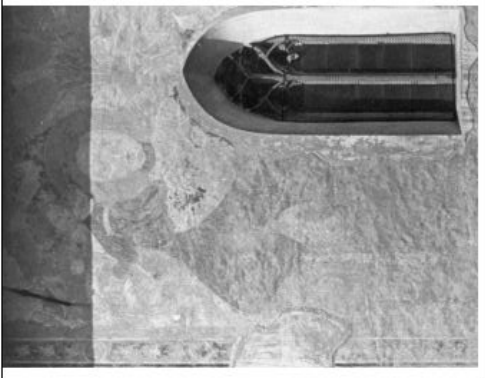
Figure 39: Church of Mary's Annunciation at Crngob, the rate of change in surface appearance over a timescale of more than five decades.

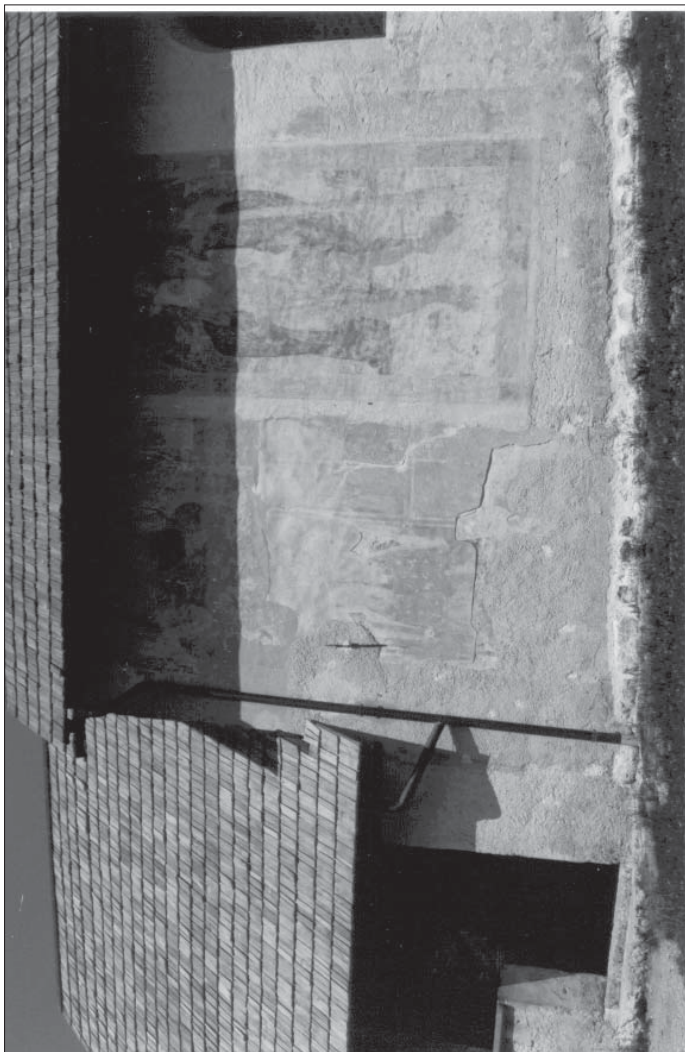
Figure 41: St. John in Bohinj (Ribčev Laz), south wall of the nave; four fragments of images of St. Christopher have been preserved – the first three paintings from the middle ages (on the left of the wall) were painted one over another, the last painting dates from the baroque period and was painted next to them on the right hand side.
